## 8 Appendices

## 8.2 Appendix B: Operation of REFCLs<sup>28</sup>

### 8.3 Appendix C: Test records

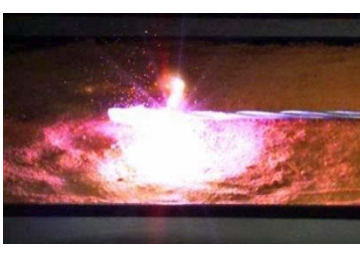
Figure 65: Fulgurite formation in February 2014 proof-of-concept tests at Ausgrid/TCA Lane Cove West facility

<p>Immediately prior to fulgurite formation</p>	<p>Fulgurite 'punch through' to soil bed metal casing</p>	<p>Typical fulgurite structure dug out of soil, about 100 millimetres long</p>

It was observed that fulgurites were a potent cause of ignition. High speed video records demonstrated that the open end of a fulgurite ejects copious amounts of incandescent molten siliceous material which rapidly ignites surrounding vegetation.

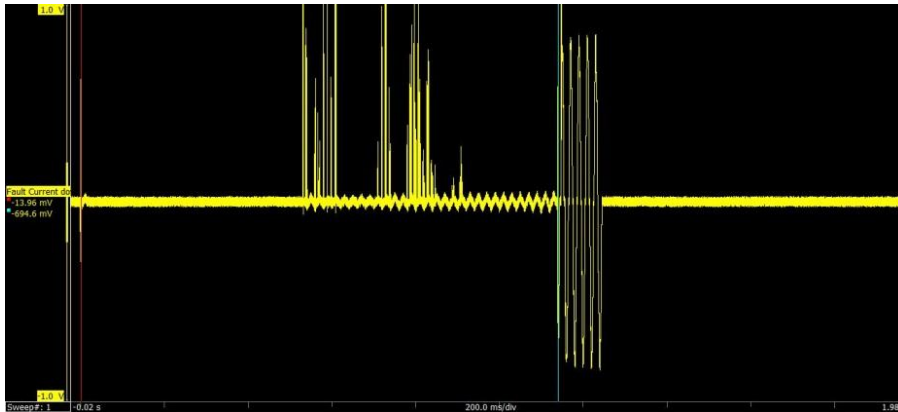
Figure 66: Test 20 fulgurite formation in 1.14 seconds – soil current record

Figure 66 through to Figure 69 show the soil current waveforms for NER tests where fulgurite formation occurred. Once a fulgurite occurred, it acted as a short circuit and the current was limited only by the 100 ohm series resistor in the rig supply, i.e. it was 110 amps. The on-site current records often showed clipping of peaks when a fulgurite formed as the fulgurite current was greater than the full-scale current set for the test.

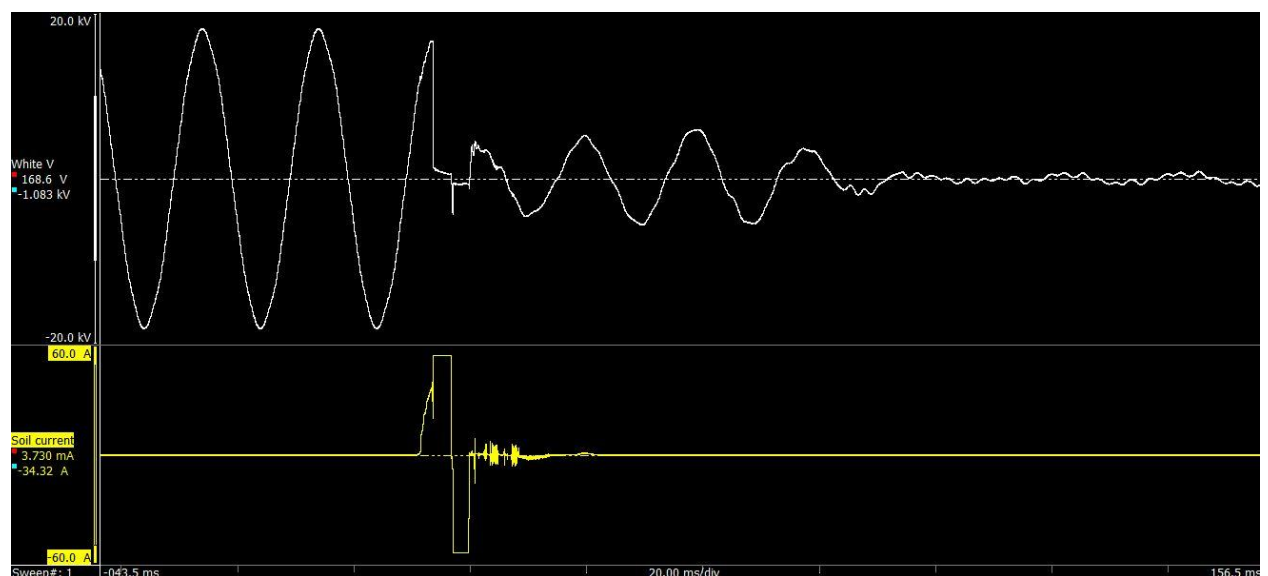
Figure 70: Test 208 fulgurite formation in a GFN test - on-site recordings

On-site records revealed the fulgurite arc extinguished and normal soil current behaviour (about one amp) was recorded from that point on. The conductor voltage recovered to about 4.0kV before the RCC response at around the 60ms mark reduced it to normal residual voltage levels.

1. It was the only instance of fulgurite formation in more than a hundred REFCL tests (apart from Test 217 described below which was the result of a heavy cross-country fault).
2. The fulgurite formed within three milliseconds of conductor-soil contact. This rapidity had never been seen before, even with the prototype metal-sided soil bed designs which were quite susceptible to fulgurites. Typically, fulgurite onset times were tens to hundreds of milliseconds.
3. The arc current in the fulgurite was not 50Hz current but appeared to be around (but not quite equal to) the third harmonic, with a period close to 6.3ms.

4. The fulgurite arc extinguished after a single cycle of heavy current. No other fulgurite had been observed that had done this. In all other cases, once a fulgurite had established itself to the extent it had conducted current for two half cycles, it persisted until the power was cut off.
5. Test 208 was a GFN test with zero series resistance between the network and the test rig. It was known that this configuration produced what appeared to be a form of ferro-resonance in bolted fault tests.

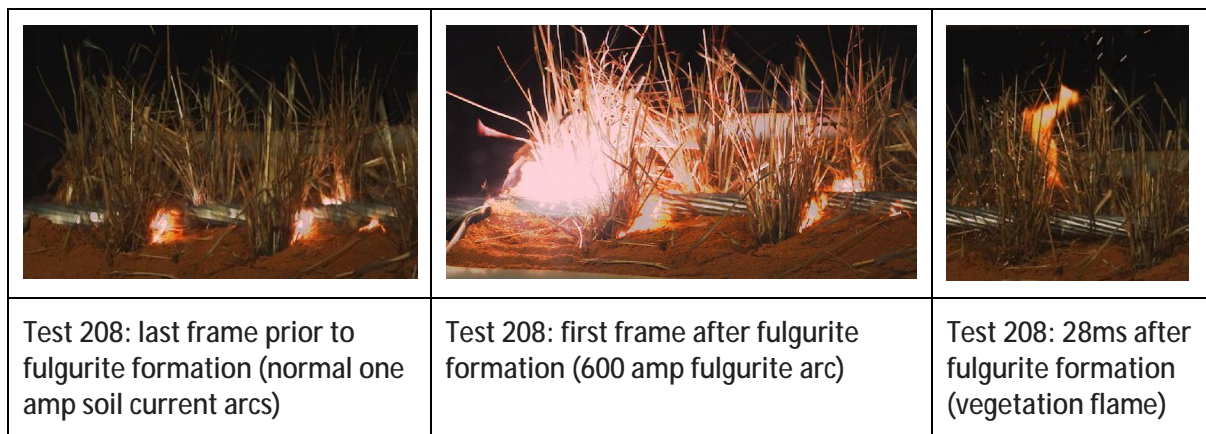
Figure 72: Test 208 high speed video record of fulgurite formation

High speed video showed the typical appearance of a fulgurite: extremely bright light emission and ejection of incandescent molten material flowed by ignition of vegetation.

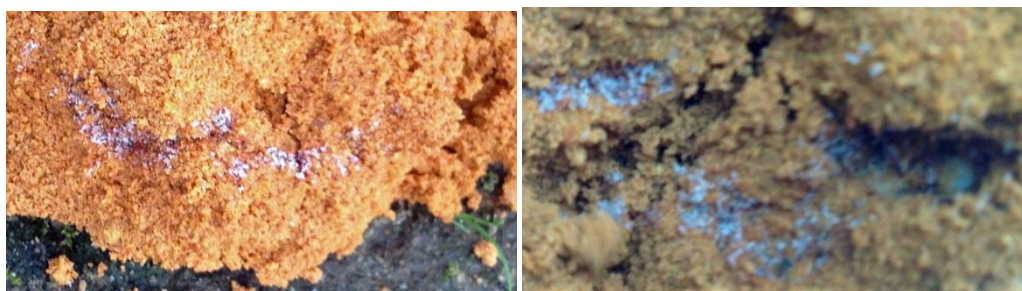
Figure 73: Test 208 fulgurite track through soil

The fulgurite current in Test 208 was too brief to form the normal glass-lined tunnel through the soil bed. However, the track of the current was clearly visible as can be seen in Figure 73.

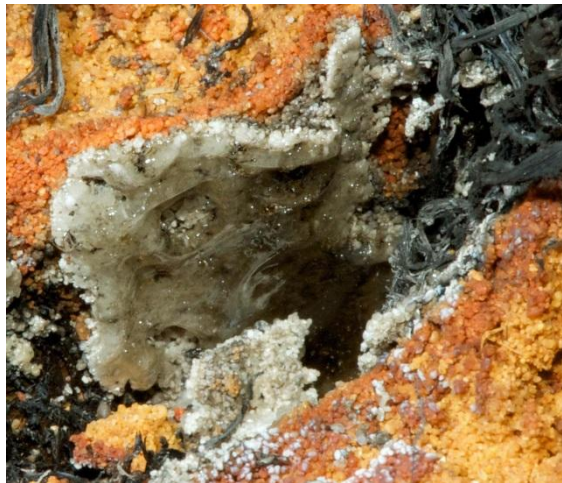
Figure 74: fulgurite formed in Test 217

The mouth of the fulgurite formed in this event is shown in Figure 74. The glass lining of the hollow tube that contained the arc is clearly visible.

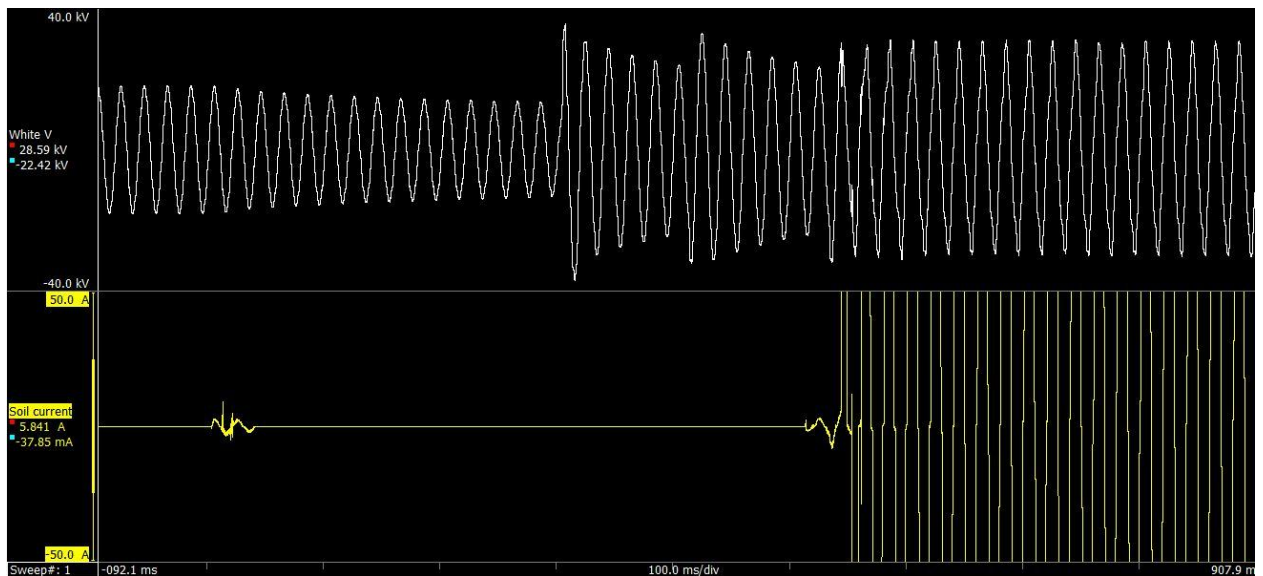
Figure 75: Test 217 fulgurite formation due to cross-country fault

In Test 217 a cross-country fault occurred during a GFN ignition test with a 100 ohm resistor in series in the rig supply. This caused the voltage applied to the rig during the test to rise to 22,000 volts and a fulgurite formed quickly after the second conductor bounce.
